Scarborough, South Cliff Shelters

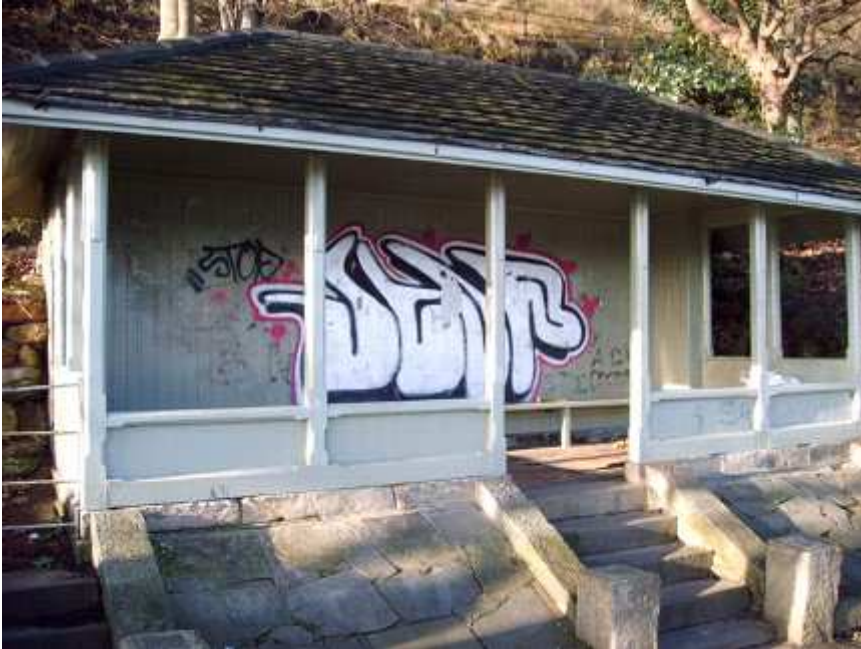
Before repair Shelter 1

Large shelter on main path from Spa Chalet to The Spa. Sound modern roof, but guttering has gone. Some floor tiles missing. Seating reasonable, definitely usable. Good view. From a design stand-point it is quite simple and practical rather than picturesque.

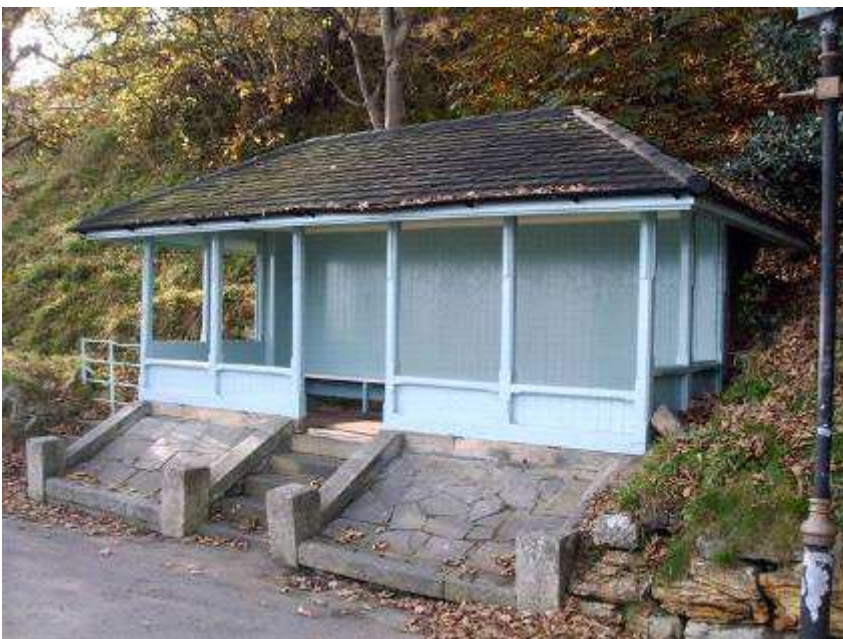
Repaired Shelter pictured November 2007

Comments made after repair.
Floor tile repairs have been a major improvement.

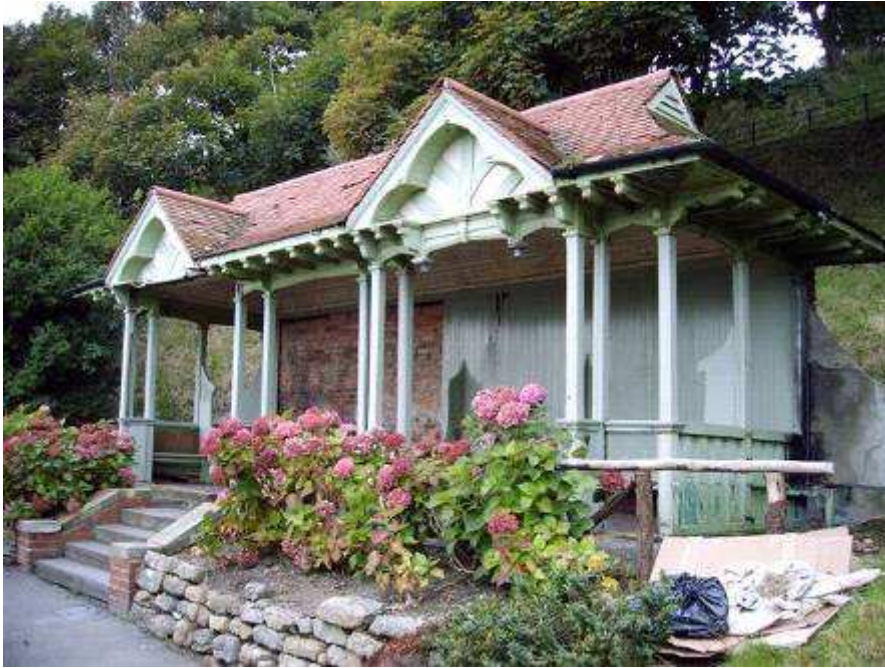
Before repair Shelter 2

Large shelter near back of The Spa buildings. Beautiful building with gables and coved ceiling. Roof badly in need of repair: broken and slipped red tiles. Half of the seating missing. Half the timber wall cladding missing. Some timber frontage missing. Fire damaged. The hydrangeas in front make the building look even prettier.

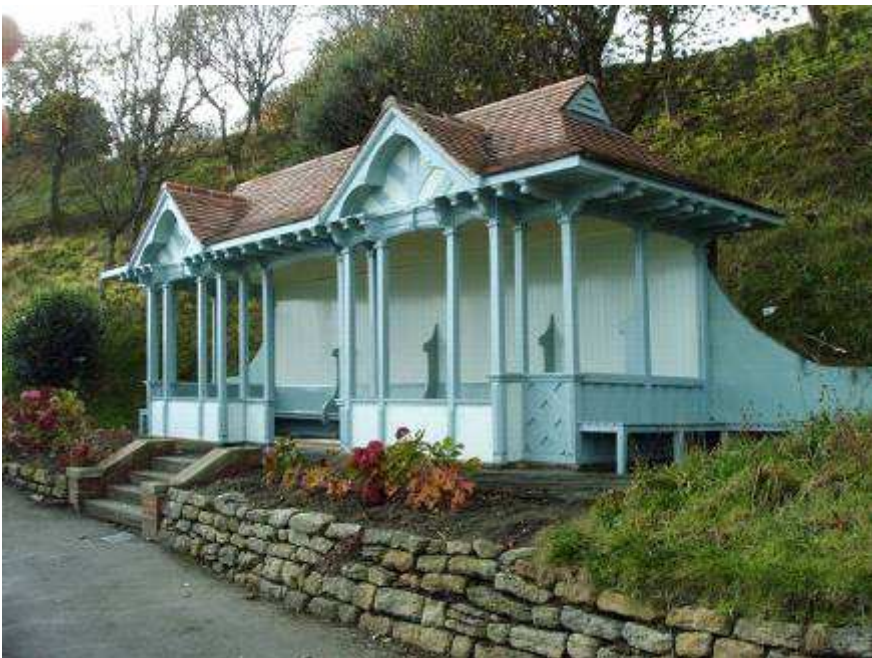
Repaired Shelter pictured November 2007

Looks stunning!

Even the outside seating areas have been reinstated!

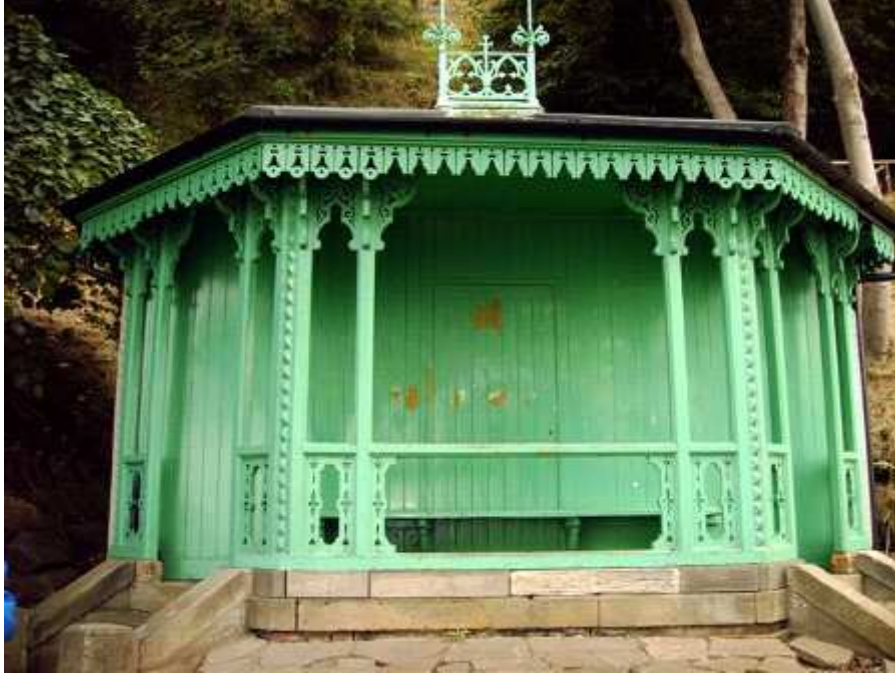
Before repair Shelter 3

It is near the top of the Paxton Staircase at the rear of The Spa. The timber detailing on this seems to be the most elaborate of any of the shelters. Shows signs of recent small fire. Ceramic tiled floor. Sound modern roof and guttering

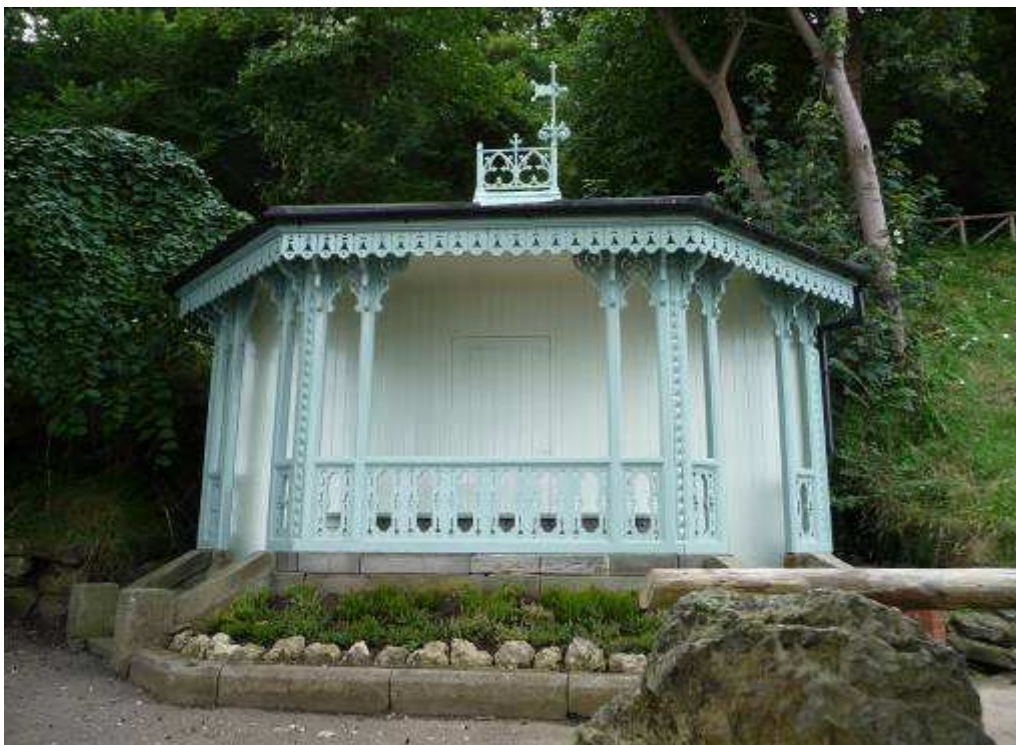
Repaired Shelter pictured September 2008

The planting of heathers in front of the shelter will improve the overall appearance.

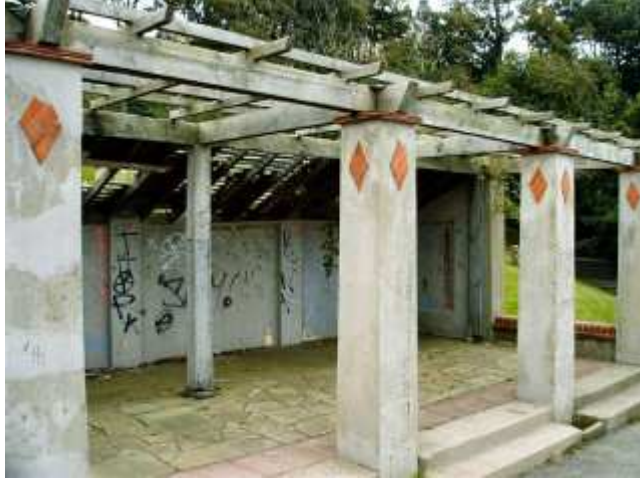
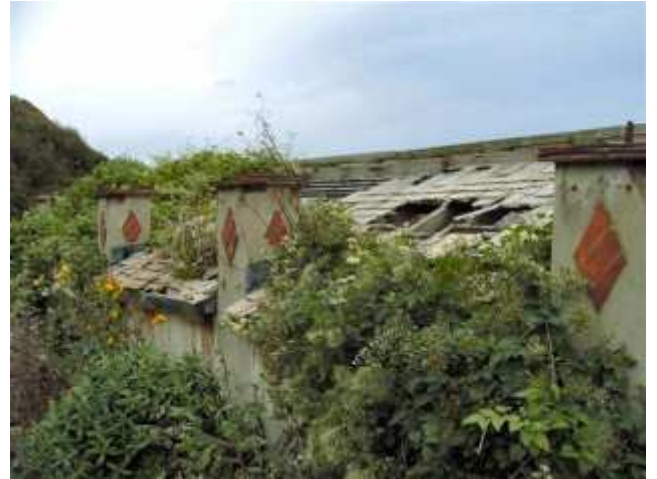
Before repair Shelter 4

Large substantial structure in concrete. Wooden roof shingles. Roof very badly damaged. (half roof, half pergola). No seating at all. Lots of graffiti. Good open view. Potentially very attractive.

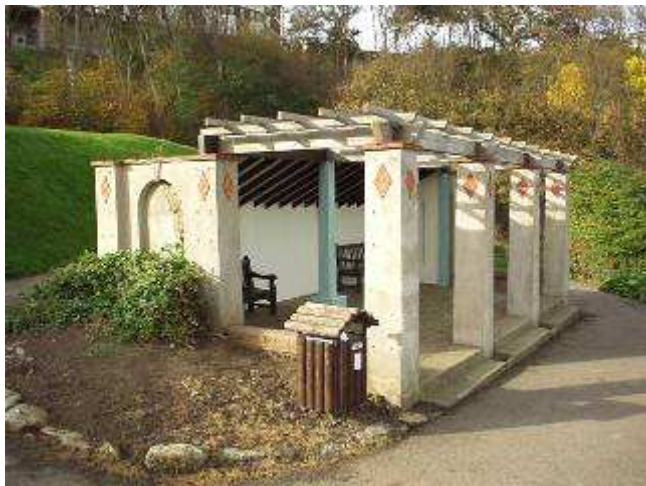
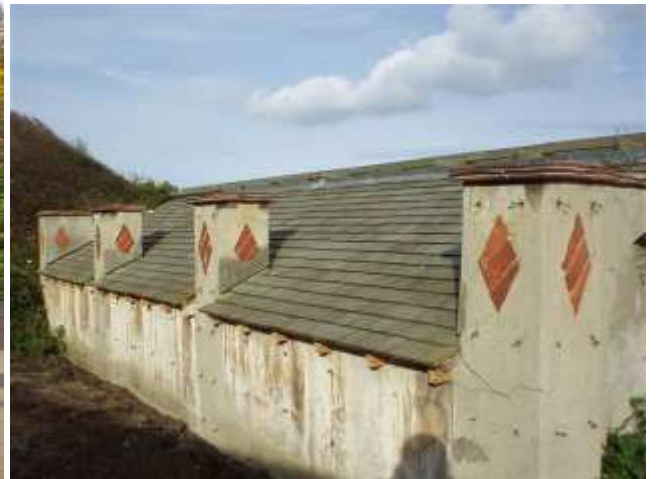
Repaired Shelter pictured November 2007

Looks very good. The structure enhances the appearance of the park. Some repainting still needs doing.

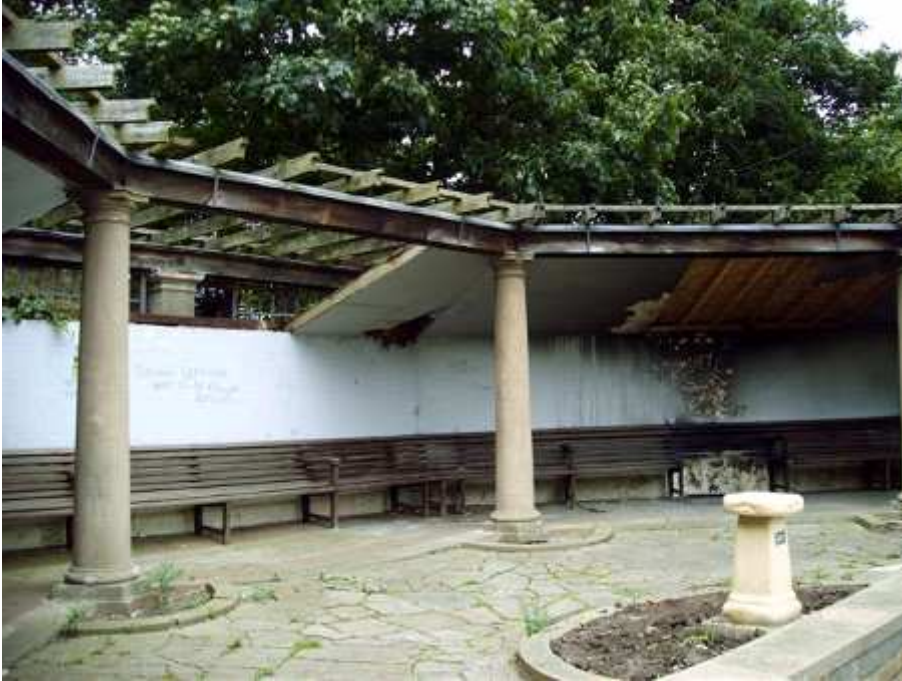
Before repair Shelter 5

Large, substantial shelter. Roof badly damaged. Signs of fire damage. Most of seating intact. Stone and concrete floor. Graffiti. Good view of Italian Gardens. Very attractive building. Rather untidy. In view of the damage to both shelters and the statue in the Italian Gardens, it would seem a good idea to consider the feasibility of installing a CCTV camera here.

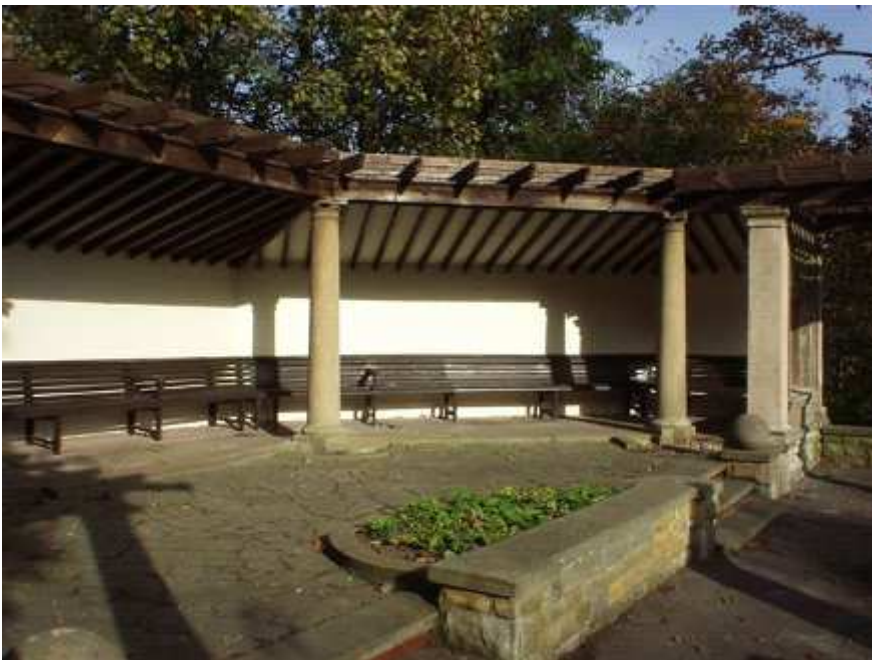
Repaired Shelter pictured November 2007

A vast improvement although some details still need attention. A deep crack in the floor needs attention as there is a void beneath.

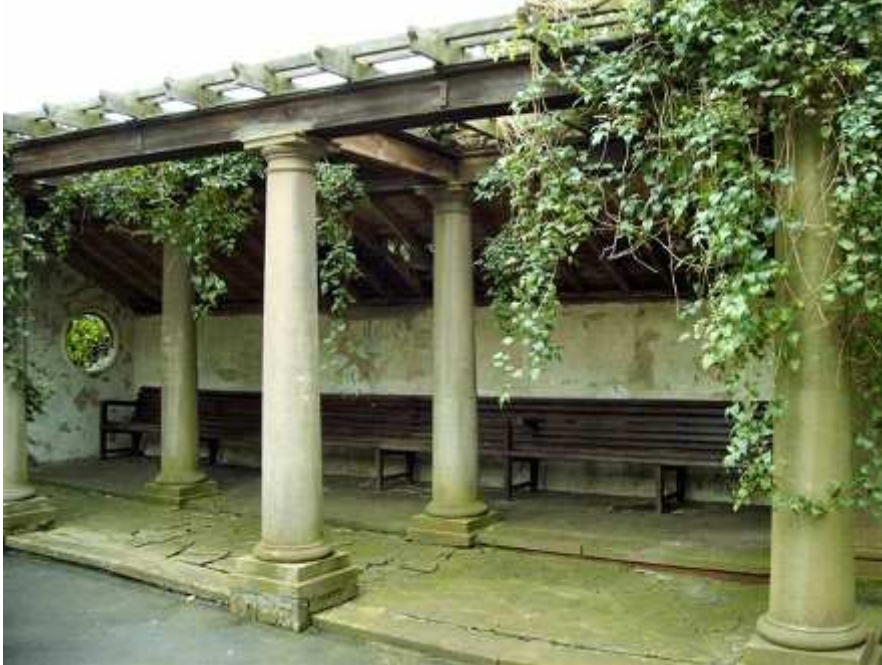
Before repair Shelter 6

Substantial building of stone, concrete and stucco. Classical style. Half roofed, half pergola. Large hole in roof. Under drawing of roof has disappeared. Many roof tiles damaged and displaced. Stone and concrete floor. Bench intact. Little graffiti. Very attractive. Gives good view of Italian gardens

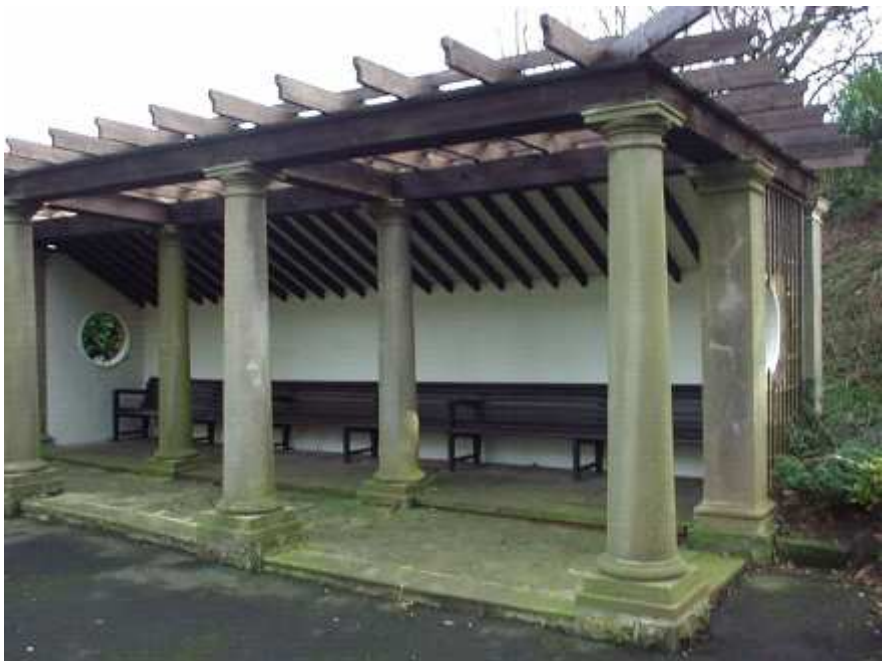
Repaired Shelter pictured November 2007

A vast improvement although some details still need attention.

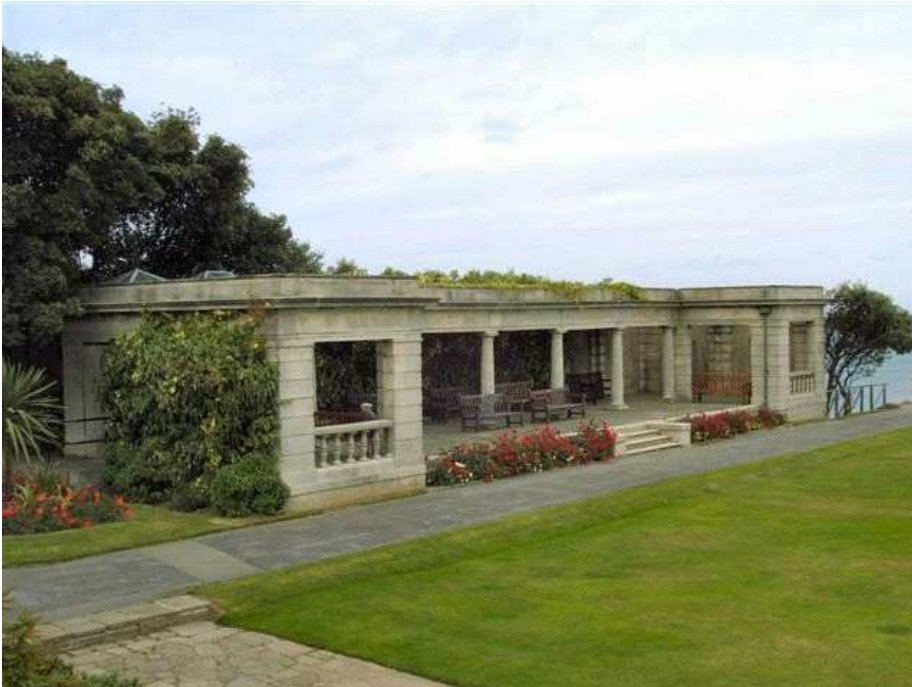
General View of Shelter 7

Very substantial in both size and construction. No fixed seating. Timber pergola at the front. Concrete construction. No graffiti!! Attractive classical style with columns. Very clean and tidy.

Wonderful view southwards. In good condition except for a hole in the pergola.

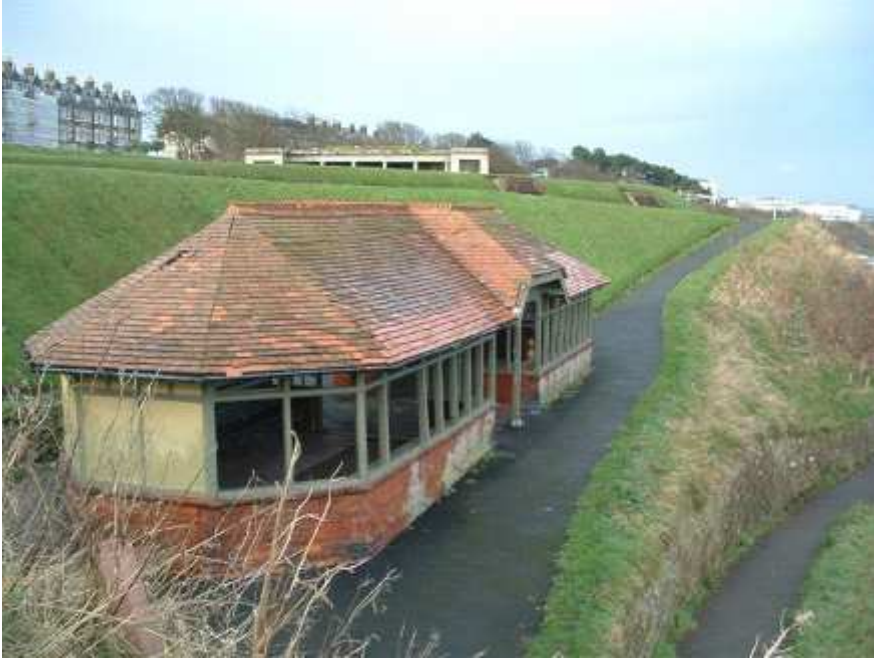
General View of Shelter 8

Large, once-attractive building, but now in very bad condition. Not much external timber. Walls internally ceramic tiled. Red tiled roof, many tiles slipped and broken. Suspect vandals have caused some of the damage. Ceramic tiled floor very dirty and untidy, with lots of tiles missing. Guttering damaged. Wonderful open view. Internally timber ceiling seems sound, but there is a crack in the wall tiles showing daylight through. Seating almost unusable. This shelter is in most immediate need of attention.

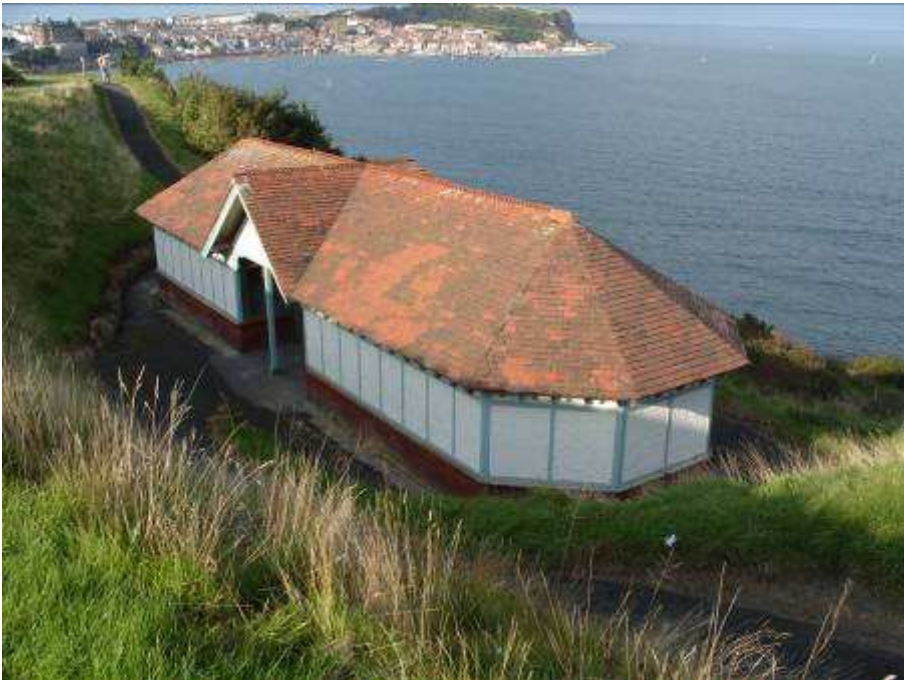
Repaired Shelter pictured October 2008

This shelter has had some work done by the Council and the painting has been done by volunteers. It is still in need of a more thorough job but now looks presentable and the roof is weather proof.

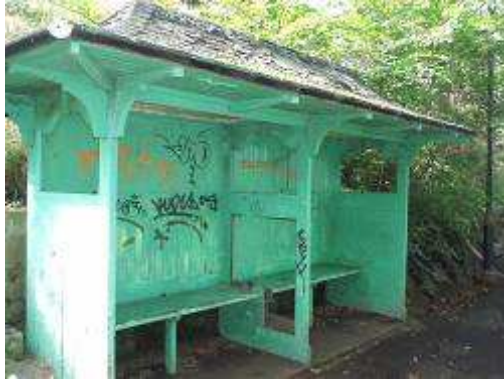
Before repair Shelter 9

Attractive building. Roof seems intact. Seats still usable. Graffiti inside. Some guttering missing. Needs repainting. Some timber decay internally. No view because of trees. Lamp-post (might give night-time security?)

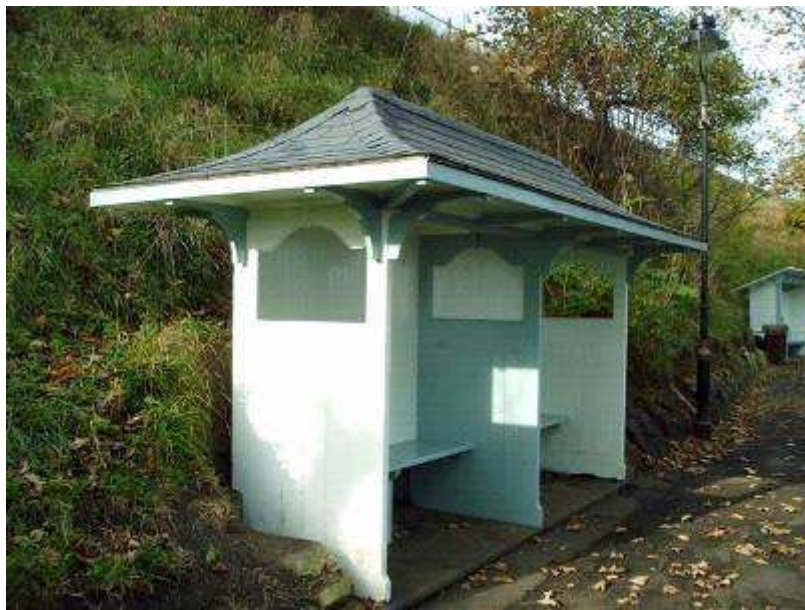
Repaired Shelter pictured November 2007

Looks stunning!

It was a shame that replacement fish scale roof tiles could not be sourced.

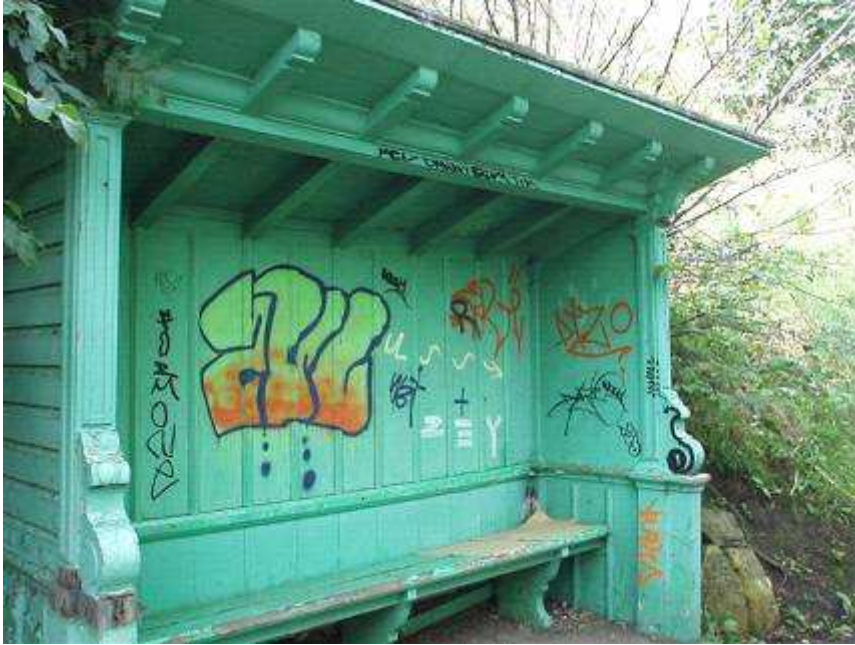
Before repair Shelter 10

This is very close to shelter 9, but a very different design. Roof seems intact. Seat just about usable. Graffiti inside. Internal timber damage. Needs repainting. No view because of trees. Attractive building.

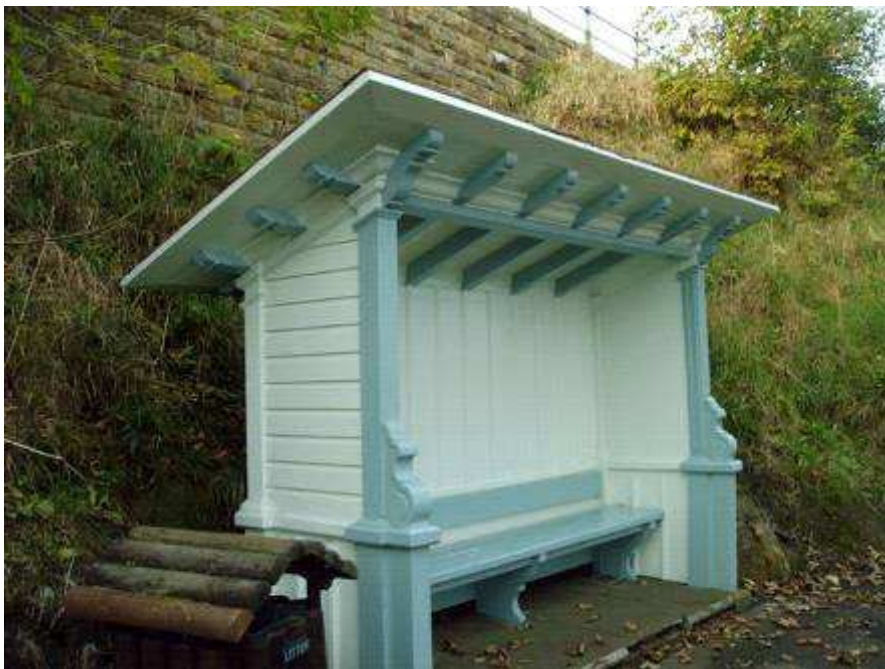
Repaired Shelter pictured November 2007

Looks very smart.
New bench fitted.

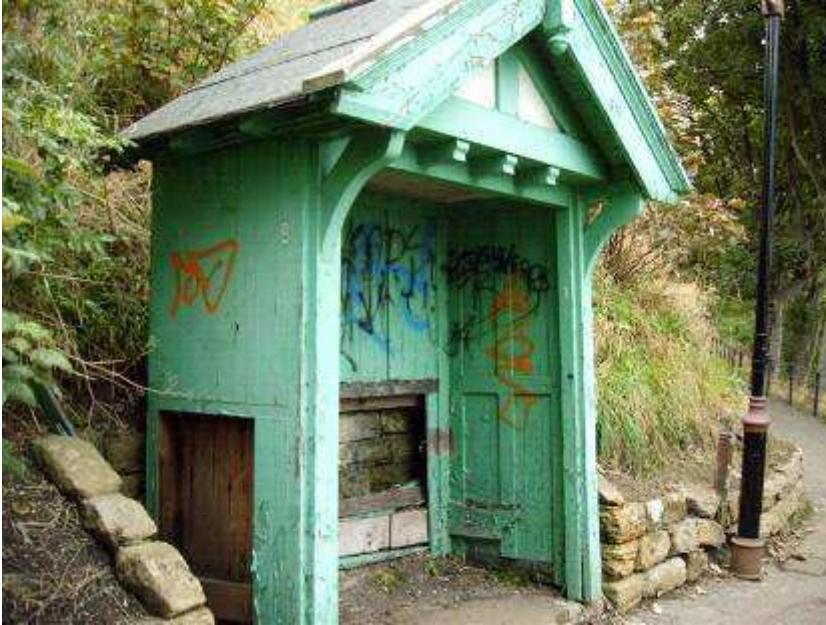
Before repair Shelter 11

Some roofing felt missing. Internal timber missing. No seat at all. Graffiti inside. Needs repainting. View through trees to roof of Spa Grand Hall and sea. 3 trees in front of shelter have been thinned/pruned.

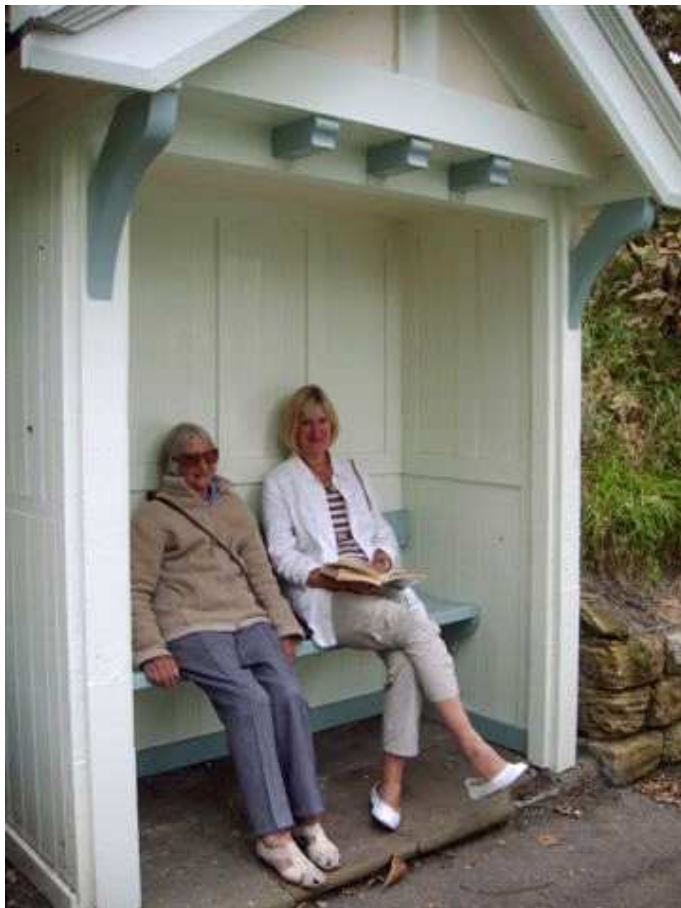
Repaired Shelter pictured September 2007

Looks stunning!

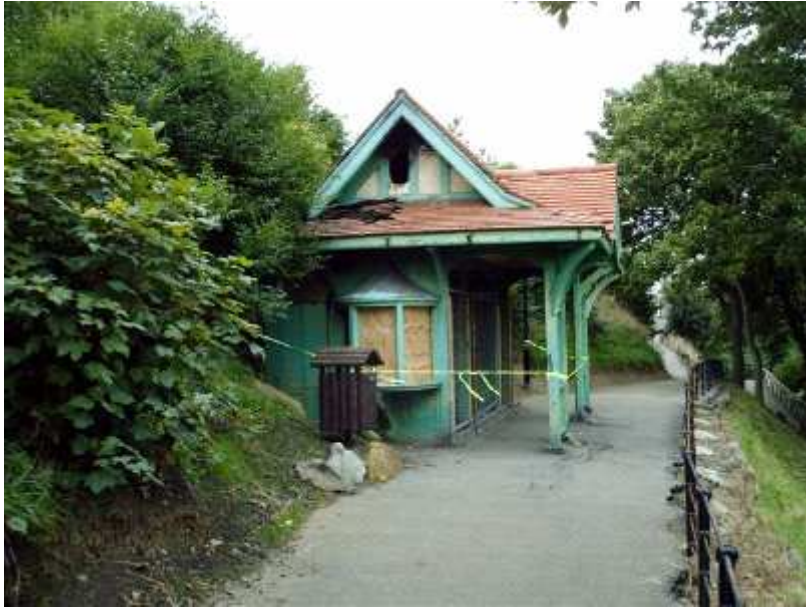
Before repair Shelter 12

This shelter was badly fire damaged. A particularly attractive shelter and quite large. Lamp-post nearby clearly did not provide security! Not much view from this shelter.

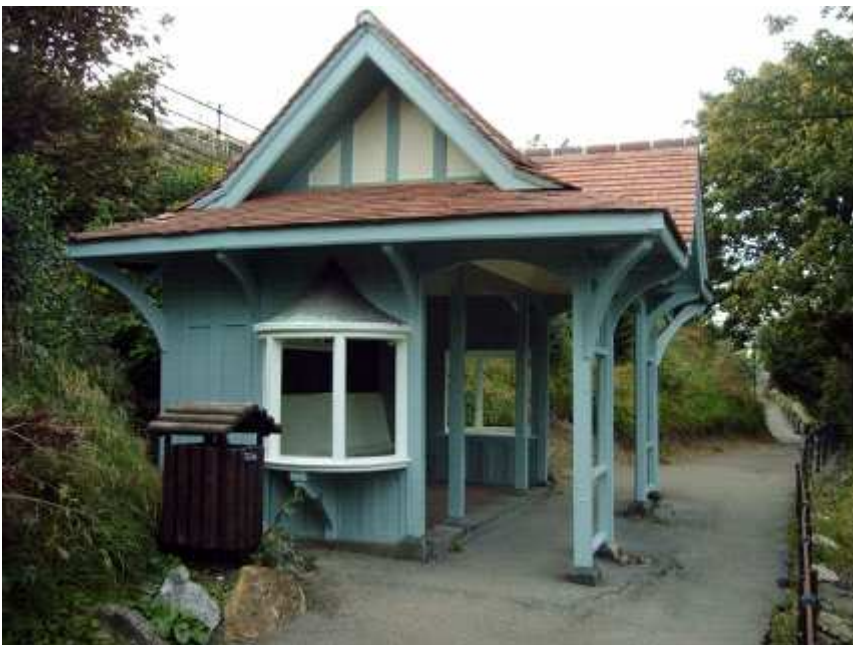
Repaired Shelter pictured September 2007

Looks stunning!

This will need close monitoring because the "drinkers" seem to like the location!

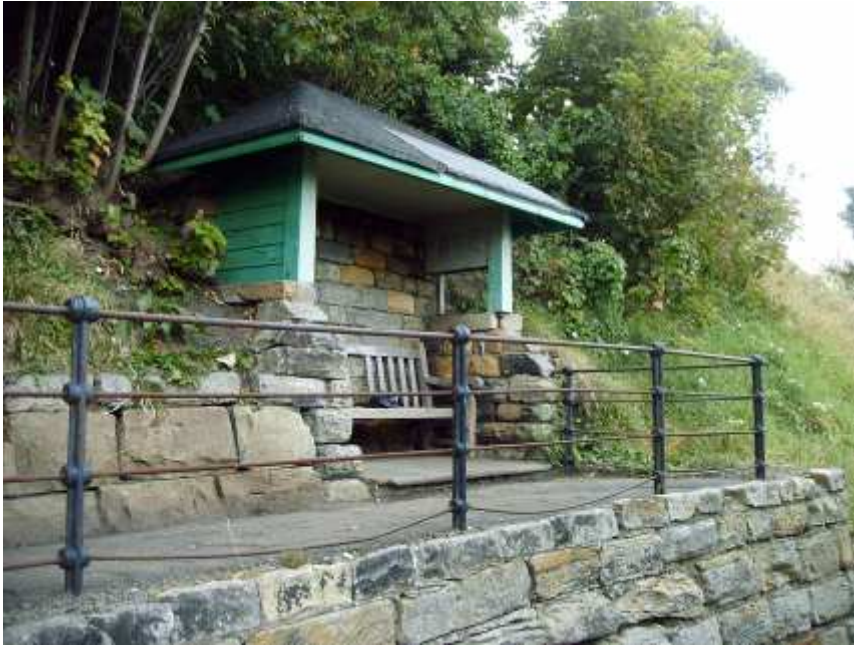
Before repair Shelter 13

Small, simple shelter. Mainly stone with timber side half-walls and roof. Roofing felt coming off. Graffiti. There is a memorial bench inside. No lighting nearby. Very secluded on a dead-end path. Good view over the sea and Scarborough.

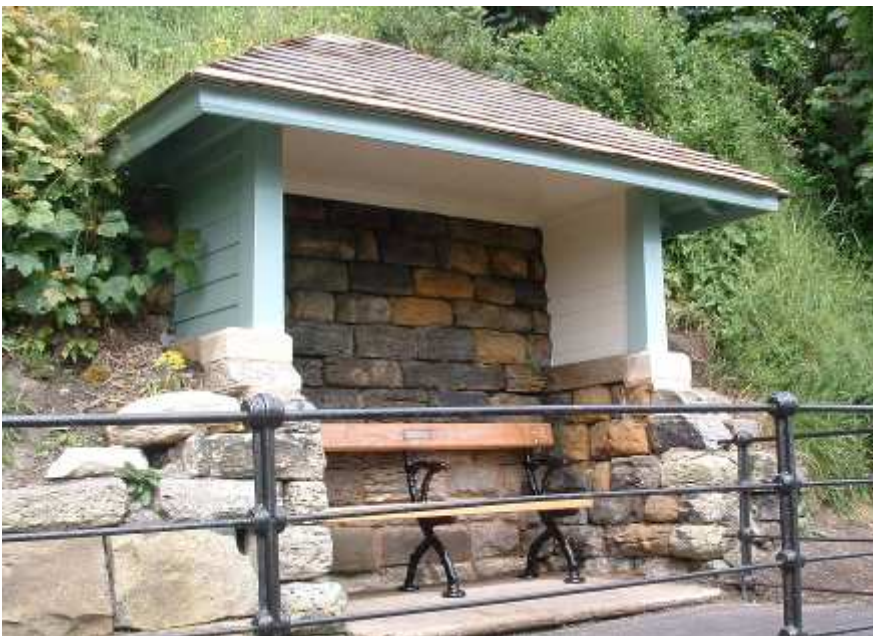
Repaired Shelter pictured June 2008

Looks very smart. Funding for the repair was provided by Yorkshire Forward and North Yorkshire County Council
Special thanks are due to Cllr Fox and County Cllr Martin Smith who made this possible.
